## **Hybrid Design/Build Approach for Quaywall 729**

### **ABSTRACT**

To support aircraft carrier maintenance at Puget Sound Naval Shipyard & Intermediate Maintenance Facility, the U.S. Navy retained BergerABAM to develop a request for proposal (RFP) for the replacement of Pier B and the retrofit of Quaywall 729. Due to a confined design and construction schedule for the design/build (D/B) team, the substructure design of Quaywall 729 was performed by BergerABAM and incorporated into the RFP document as a prescriptive design. This paper highlights the benefits and challenges associated with the combination of D/B with prescriptive requirements (design/bid/build) from the development of the RFP package through final design and construction by the D/B team.

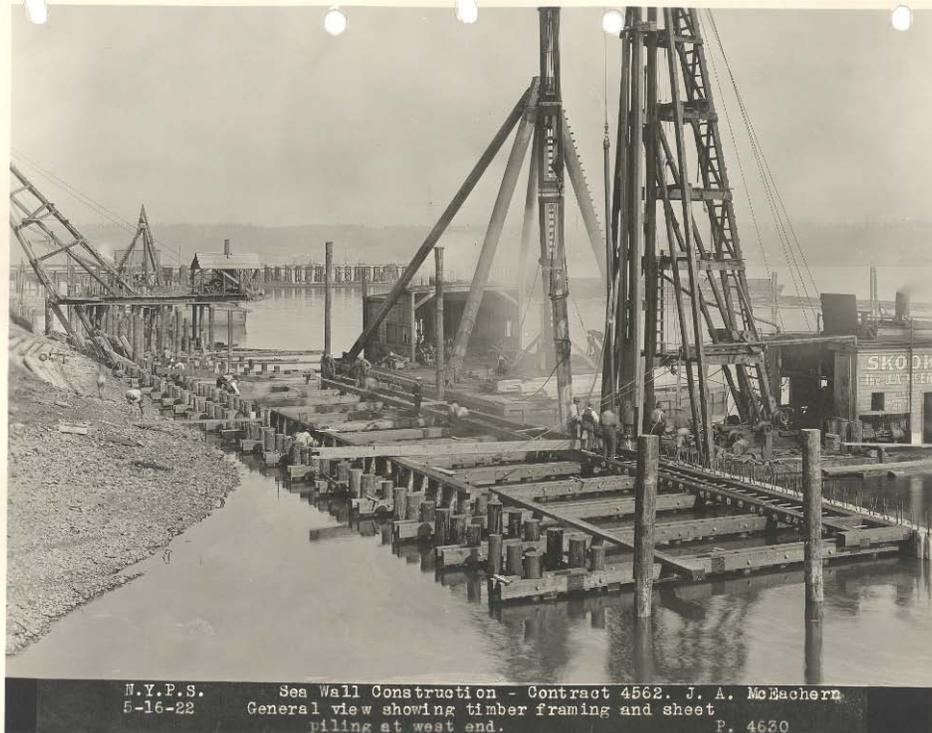
**Figure 2. Original quaywall in construction, 1922.**

Built in 1922, Quaywall 729 serves as a deep-water bulkhead for 580 feet (177 meters) of shoreline. Originally constructed offshore, the quay structure acts as an abutment to retain the fill placed between the quay and the existing shore, allowing the Shipyard to expand out to the deep water necessary for berthing large ships. The average mud line depth is 36 feet (11 meters) below the top of the quay deck. In construction of the quay, closely spaced plumb and batter timber piles were driven into the native beach and timber pile caps were used to interlock the tops of all the piles. The timber pile caps were unique because they were not directly on top of the piles, but rather bolted to the side of piles and only functioned during the construction of the quay. The tops of the timber piles and the pile caps were roughly 16 feet (5 meters) below the final quay deck. With the timber piles framed together with the pile caps, concrete sheet piles were jetted into the native soil along the outboard face of the quay and bolted back at the top to the timber pile caps, relying on the timber

batter piles for lateral restraint. A photo of the timber substructure of the original Quaywall 729 in construction is shown in Figure 2.

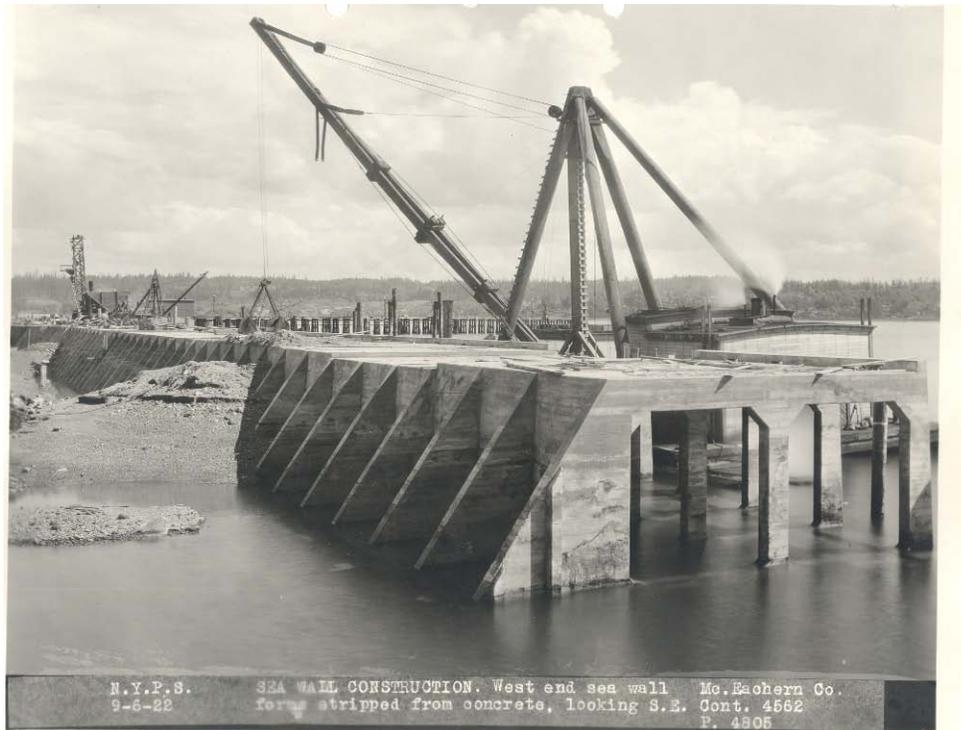
**Figure 3. Original quaywall in construction, 1922.**

With the concrete sheet pile wall restrained at the top, fill material was placed behind the sheet piles until it was level with the top of the timber pile caps. Then, using this fill as a working surface, a two-bay concrete portal frame, 26 feet wide by 16 feet tall (8 by 5 meters), was constructed with bents at 10 feet (3 meters) on-center, matching the timber pile caps. Over the closely spaced batter piles, a continuous concrete counterfort wall was constructed, and a deck was cast atop the portal frame. As noted previously, the timber piles extended through the timber pile caps, allowing the piles to be cast directly into the concrete pile caps and the base of the counterfort wall. In addition, the top of the concrete sheet piles were encased in a continuous concrete pile cap. A photo of the concrete portal frame, counterfort wall, and deck is shown in Figure 3. Once the counterfort wall was finished, more fill material was placed behind it to bring the ground level with the deck of the portal frame.

Shortly after construction of the concrete portal frame and counterfort wall, the fill material that brought the surface up to the top of the timber piles had settled, exposing the top of the timber piles. To correct this, additional fill material was sluiced in from the open waterside of the portal frame to bury the timber piles and the lower portions of the concrete pile caps. Keeping the timbers buried was critical to maintain the life of the structure because the timber piles, which were untreated, support the quaywall structure, both vertically and laterally. Exposure to the marine environment would allow aerobic conditions to develop and result in conditions conducive to the quick deterioration of the timbers. (Similar quay structures, such as

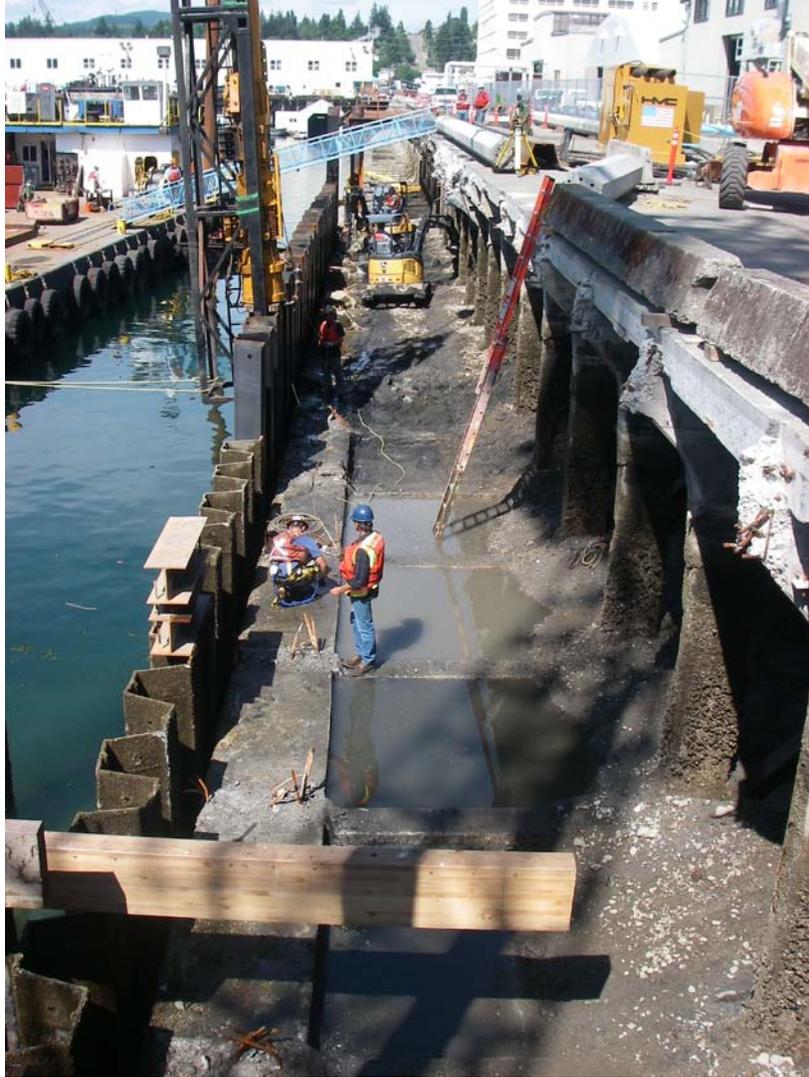
**Figure 5. Quaywall 729 driving sheet piles, 2009.**

While the prescriptive and performance designs came together without major difficulties, the prescriptive reinforcing shop drawings in the locations between the designs submitted during construction within the fast-track process provided additional challenges. The first prescriptive stage of the quaywall substructure construction progressed as planned, but when construction of the performance-based portion of the structure was approaching, it was discovered that the shop drawings did not reflect the both the prescriptive and performance aspects of the submittal. In addition, the typical project changes and RFIs combined to make numerous avenues for change to the project. To combat the potential for confusion, review meetings were held well prior to major concrete pours between the Navy, the prescriptive designer (the RFP development team), and the D/B contractor. At these meetings, all parties reviewed known modifications to the base prescriptive design to ensure seamless integration between the prescriptive and performance designs. Figures 5 and 6 show Quaywall 729 under construction.
