## **Manzanillo Container Terminal Redevelopment: Maximizing Throughput in a Limited Space**

John Bardi, PE, MASCE<sup>1</sup> and Ing. Daniel Ingram<sup>2</sup>

### **ABSTRACT**

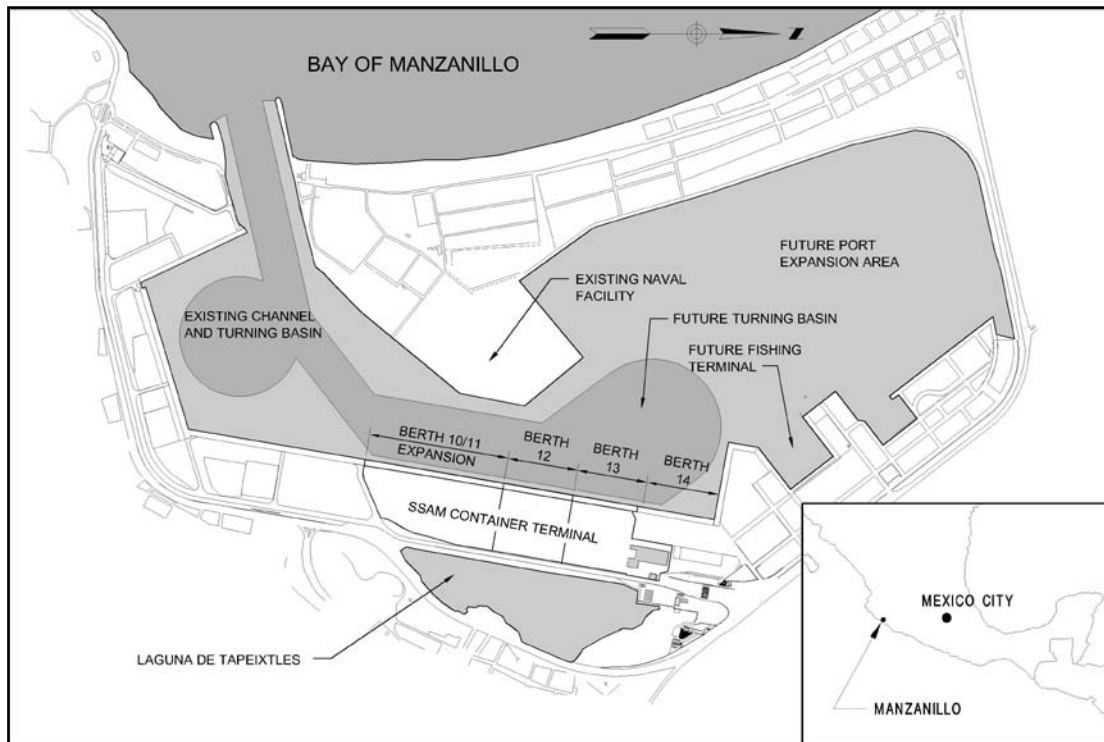
The terminal is located in an area of reclaimed swamp, on a strip of land sandwiched between the Bay of Manzanillo on Mexico's west coast and the Laguna de Tapeixtles, as shown in Figure 1. The existing geotechnical conditions consist of 18 to 20 meters (59 to 65 feet) of alluvial materials, composed of alternating layers of loose sand and silt interspersed with lenses of peat. Analysis has shown that these loose sand deposits are subject to liquefaction under moderate levels of shaking – a phenomenon that was observed in the field in earthquakes in both 1995 and 2003, first to disastrous effect, and later mitigated by ground improvement.

**Figure 1. Site plan.**

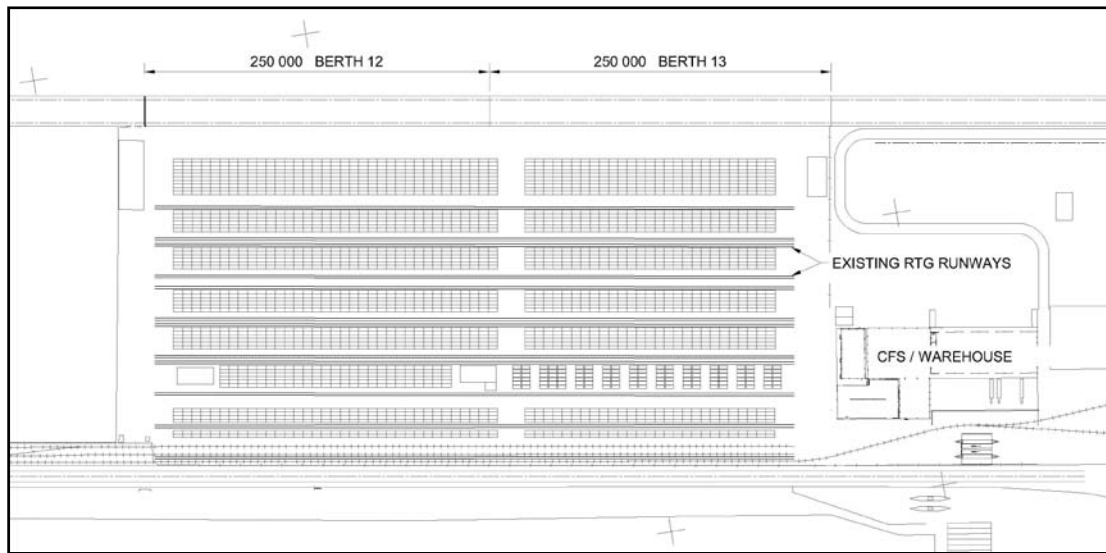
This oldest portion of the terminal assumed a dedicated rubber-tired gantry (RTG) operation, originally using 4-wheel (and later 8-wheel) machines operating on dedicated concrete runways. Figure 2 shows the typical layout of the Berth 12 container yard at the time of its construction in 2000, when it was laid out to match that of Berth 13.

**Figure 2. Berths 12 and 13 container yard layout.**

The RTG runways and high mast light poles were laid out to allow traffic circulation on either side of each machine, with truck bypass areas provided by setbacks from the intermodal area and the wharf. In use, the waterside portion of the yard was devoted to top-pick operations, and wider bypass lanes were used for equipment parking.

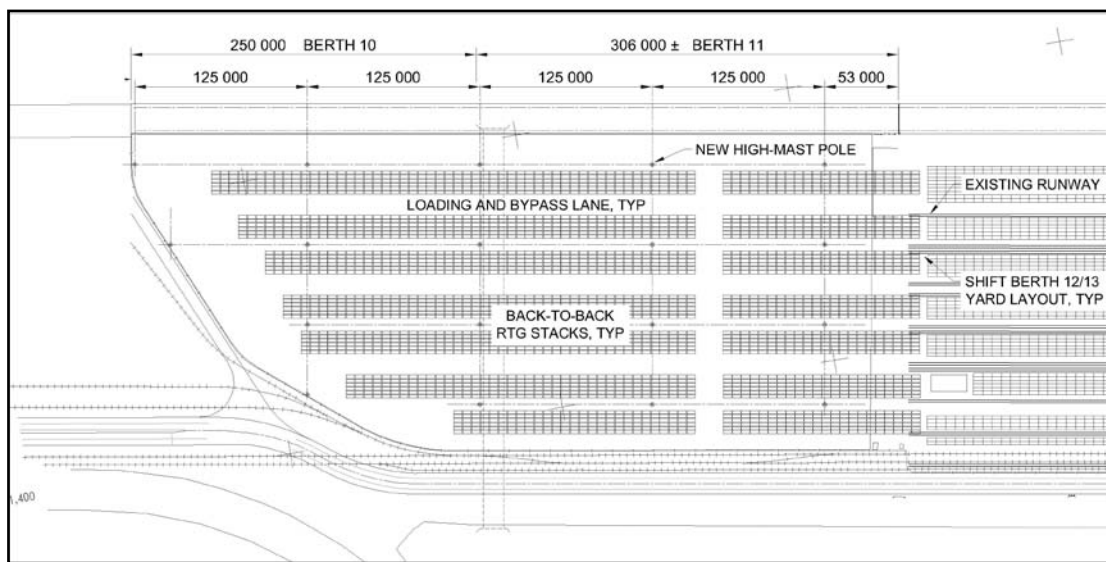
Expansion of the container terminal concession southward into Berths 10 and 11 was approved in 2007. As planning of the yard expansion was begun, lessons learned from the performance of the Berths 12/13 yard were incorporated. As described above, these included a ground improvement program, an improved paving system, and an optimized yard layout designed to maximize the relatively small available yard area, as indicated on Figure 3.

**Figure 3. Berths 10 and 11 container yard layout.**

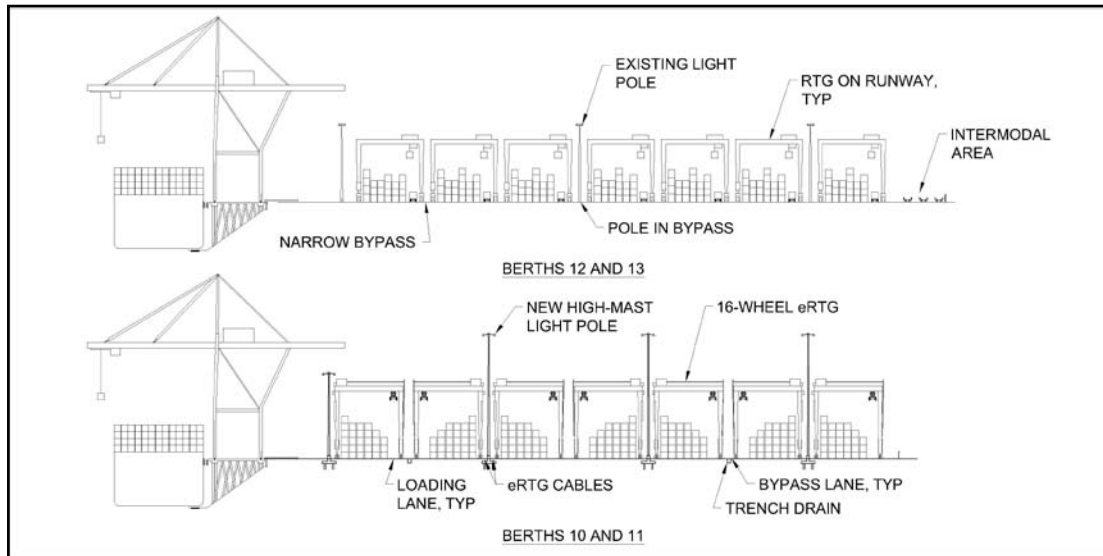
The solution came in changing from an RTG layout that had the loading lane on the same side in each stack to a back-to-back layout. That modification, in conjunction with the conversion of the relatively wide bypass areas adjacent to the crane backreach and intermodal areas, freed sufficient space for an additional RTG stack. Figure 4 compares sections through the existing Berths 12/13 yard with those of the

new Berths 10/11 expansion area and shows the shift in stacks and relocation of aisles and lighting.

**Figure 4. Comparison of berths container yard sections.**

As shown on Figure 4, the revised layout maximizes the use of the available yard space by allocating a single bypass lane to each pair of loading lanes. Although it was argued that additional space could be made available by eliminating bypass lanes altogether, the long, narrow configuration of the Manzanillo terminal meant that bypass lanes are required to move traffic efficiently from the entrance gate at the north to the exit gate at the south. Using fewer wider bypass lanes has improved the operation significantly, particularly in the case of off-terminal trucks, which had been a major source of congestion in the terminal previously.

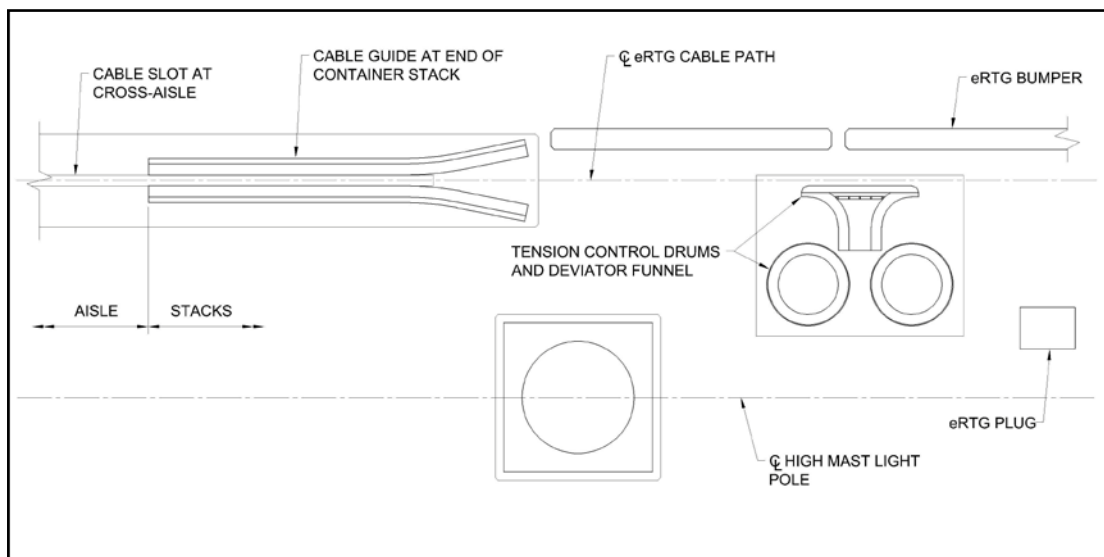
Electrification will be accomplished by fitting each machine with a cable reel that will lay cable on the existing pavement. To keep the electrification as simple and cost-effective as possible, instead of using cable trays or other cable guidance systems, the plan includes an above-ground plug connection box located in the shadow of the high mast light pole and a combination tension control bollard and deviator funnel to bring the cable safely from the plug to the guide on the RTG. Figure 5 shows a schematic of this arrangement.

**Figure 5. eRTG plug and cabling layout.**

As shown on Figure 5, the deviator funnel assures that the cable is laid in the correct alignment and that allowable bend radii and tensions are not exceeded. Traveling

away from the funnel, the eRTG lays cable on the concrete paver blocks until it reaches a cross aisle. At that point, barriers for the machine and additional cable deviators bring the cables into line and into a cable slot, allowing the eRTG to cross the aisle without unplugging and re-plugging.

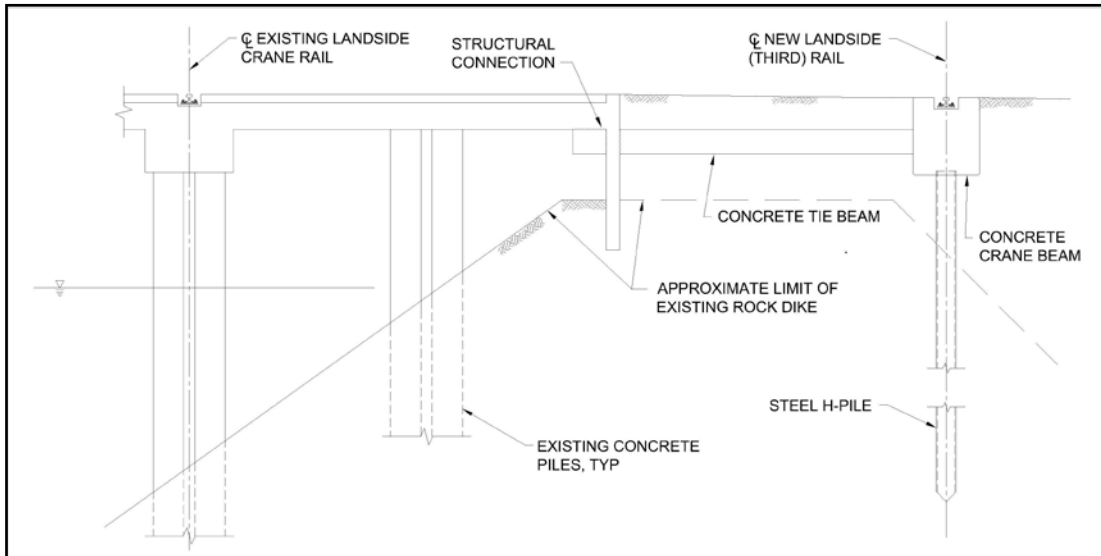
Fortunately, the increase of 13.72 meters (45 feet) was approximately equal to the space allocated for hatch cover laydown. Therefore, simply placing hatch covers between the legs of the crane rather than in the backreach preserved the bypass lanes nearest the first light pole row. As Figure 6 shows, the resulting arrangement also kept the continuity of the loading lanes on the wharf, which of course had been configured for the 16.76-meter (55-foot) gauge of existing cranes 1 through 6.

The new rail is supported on a cast-in-place concrete crane beam bearing on steel piles installed at 3 meters (9.8 feet) on-center. The design incorporates structural ties consisting of reinforced concrete grade beams connecting the third rail beam to the existing wharf at regular intervals. These tie beams maintain a constant rail gauge and also serve as drag struts to transmit inertial loads to the existing wharf in the event of an earthquake. The third rail project also incorporated new crane pin sockets and tie-downs, which were aligned with the existing waterside hardware so as to eliminate the need for additional retrofit or reconstruction.

**Figure 6. General arrangement of third rail and new/existing cranes.**

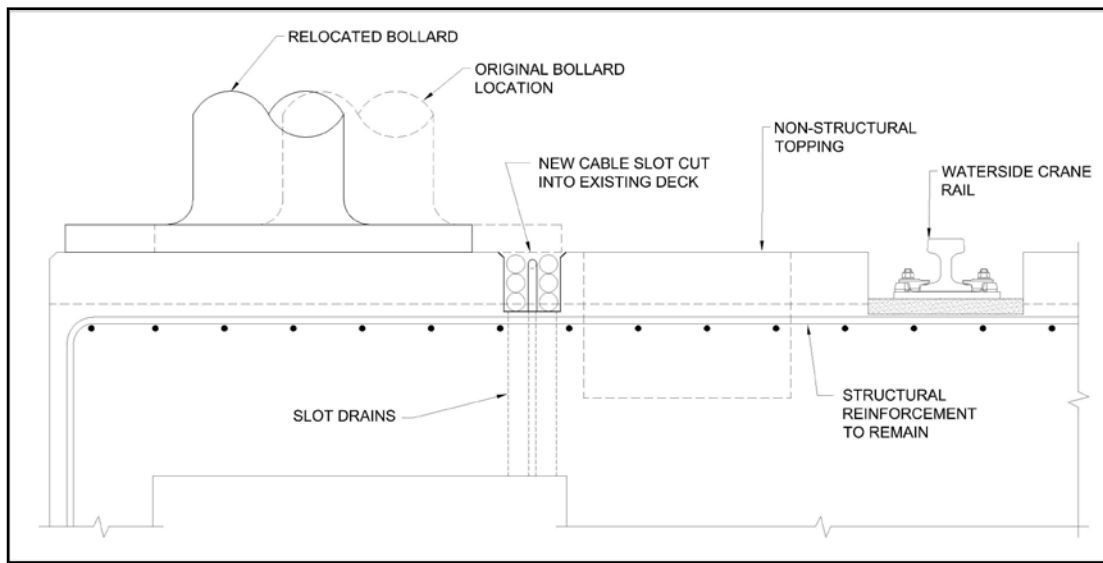
To create sufficient space for the cable slot, the existing bollards had to be shifted closer to the face of the wharf. Once that had been accomplished, a double slot was cut into the existing non-structural topping to provide sufficient width and depth for a total of six cables at any one location. The only exception was at the existing Berth 12, where the demolition required to create the slot conflicted with structural reinforcement. In this case, the existing deck was reinforced from below prior to cutting the new slot. Figure 7 shows the configuration of the wharf, including the bollards and crane rail pocket, both before and after the installation of the new cable slot. The work had to be phased and coordinated carefully with operations staff to limit down time.

**Figure 7. Waterside crane cable relocation detail.**

Relocating the existing crane power cable slot from just behind the landside crane rail to a position outside the waterside crane rail was also addressed during the redevelopment of the terminal. The slot's original position, which dated from construction of Berth 13 in 1991, was an ongoing maintenance concern – trucks often hit the slot as they transited to and from the wharf. Although the slot was provided with a flexible cover system, it had deteriorated so much that damage to the cable itself also was a concern. The team decided that relocating the slot to the wharf face – while difficult and possibly disruptive – was the best solution.
